## AVIATION INVESTIGATION REPORT

A00P0208

### MAIN-ROTOR BLADE FAILURE

MD HELICOPTER 369D, C-GXON

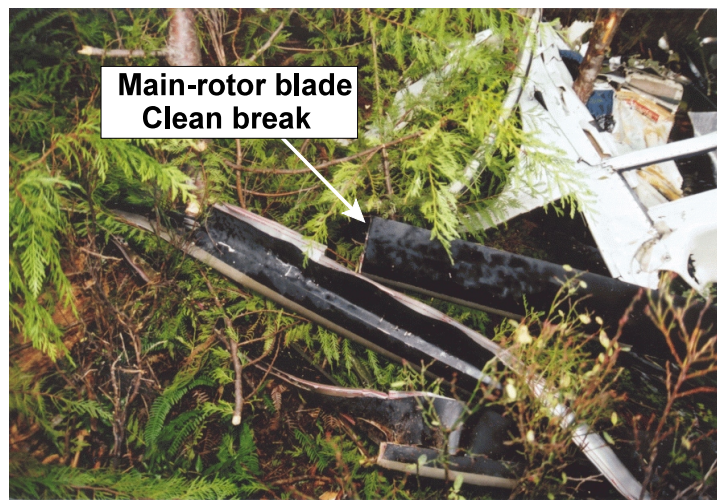
**Figure 1 - Main rotor blade break**

Marks on the aft fuselage showed that the main rotor blades had severed the tail section. All of the lead and lag blade dampers were torn apart. The helicopter is fitted with five main-rotor blades that are identified by colour. The red blade was notable in that it showed a clean break about one-third of the distance from its root (see Figure 1). The break was perpendicular to the leading edge of the blade, and the break in the spar was recessed from the skin. The outboard two-thirds of this blade was not found. The white blade was missing completely, including its main-rotor blade grip. The yellow blade was missing its end one-third and showed clear damage from hitting the tail section. The green blade was torn into two pieces after it had stopped turning. The blue blade was the only blade in one piece. Apart from the damage caused

From the available information, it was concluded that the red blade, with the clean break, failed in flight and was the initiating event in this accident. When the section of the blade was lost, a large imbalance was created in the rotor system leading to the failure of the lead and lag dampers. The imbalance would also cause extreme vibrations. The pilot would have difficulty holding onto the cyclic control stick but would be able to lower the collective control stick. There are two scenarios, either of which, or both, could result in the main-rotor blades severing the tail section. The first scenario is that extreme vibrations compromised the tail-boom strength, causing the tail section to break and flex into the path of the main rotor. The second scenario is that the loss of a large portion of a main-rotor blade created such an imbalance that the blades flew in an erratic and extreme path and struck the tail boom.

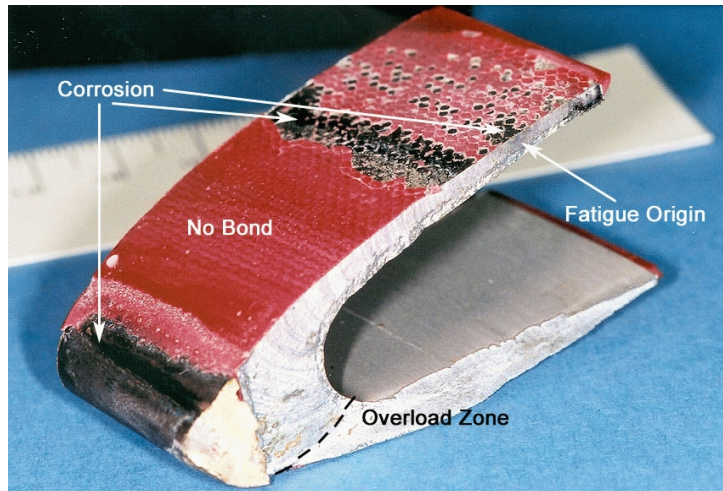
Figure 2 - Detailed view of rotor blade break

The red blade, with the clean break, was removed from the wreckage and transported to an independent engineering facility for examination. Detailed visual and scanning-electron microscope inspections revealed a bonding void between the blade skin and the spar. It also revealed corrosion pits in the spar, in the area of the bonding void. A fatigue crack had propagated from one of the pits and through the spar until the weakened blade failed from overload. The corrosion pit revealed chlorine and sulphur, as happens when the corrosion is from a marine or industrial environment.

The crack in the spar of the failed rotor blade did not manifest itself through the outer skin because of the lack of bonding between the main-rotor blade spar and the outer skin. Therefore, the crack would not have been identifiable by visual inspection before the blade failure.

1. Two thirds of one of the helicopter's five main-rotor blades separated in flight, and one or two of the remaining main-rotor blades struck and severed the tail section in flight, all of which made the helicopter uncontrollable.
2. There was no bonding on part of the skin on the main-rotor blade that separated, which allowed corrosion pits to form in the blade. A crack propagated from one of the pits, and the blade failed in fatigue. The crack in the main-rotor blade was not visually identifiable before the flight.

After confirming that there was a manufacturing flaw—the lack of bonding in the area of blade separation—in the main-rotor blade, the manufacturer of the blades took immediate action. The manufacturer informed operators of the problem and issued a Mandatory Service Bulletin on 6 November 2000 to check the bonding on affected 369D blades before the next flight. The US Federal Aviation Administration issued an Airworthiness Directive on 20 November 2000 requiring compliance with the aforementioned Mandatory Service Bulletin. The Airworthiness Directive calls for a one-time inspection, before the next flight, of all of the 369D main-rotor blades manufactured by the approved parts manufacturer and establishes new criteria for acceptable voids in all new blades.
